REPORT OF RCRA COMPLIANCE EVALUATION INSPECTION

OMEGA CAPITAL, LLC

March 25-26, 2014

U.S. ENVIRONMENTAL PROTECTION AGENCY

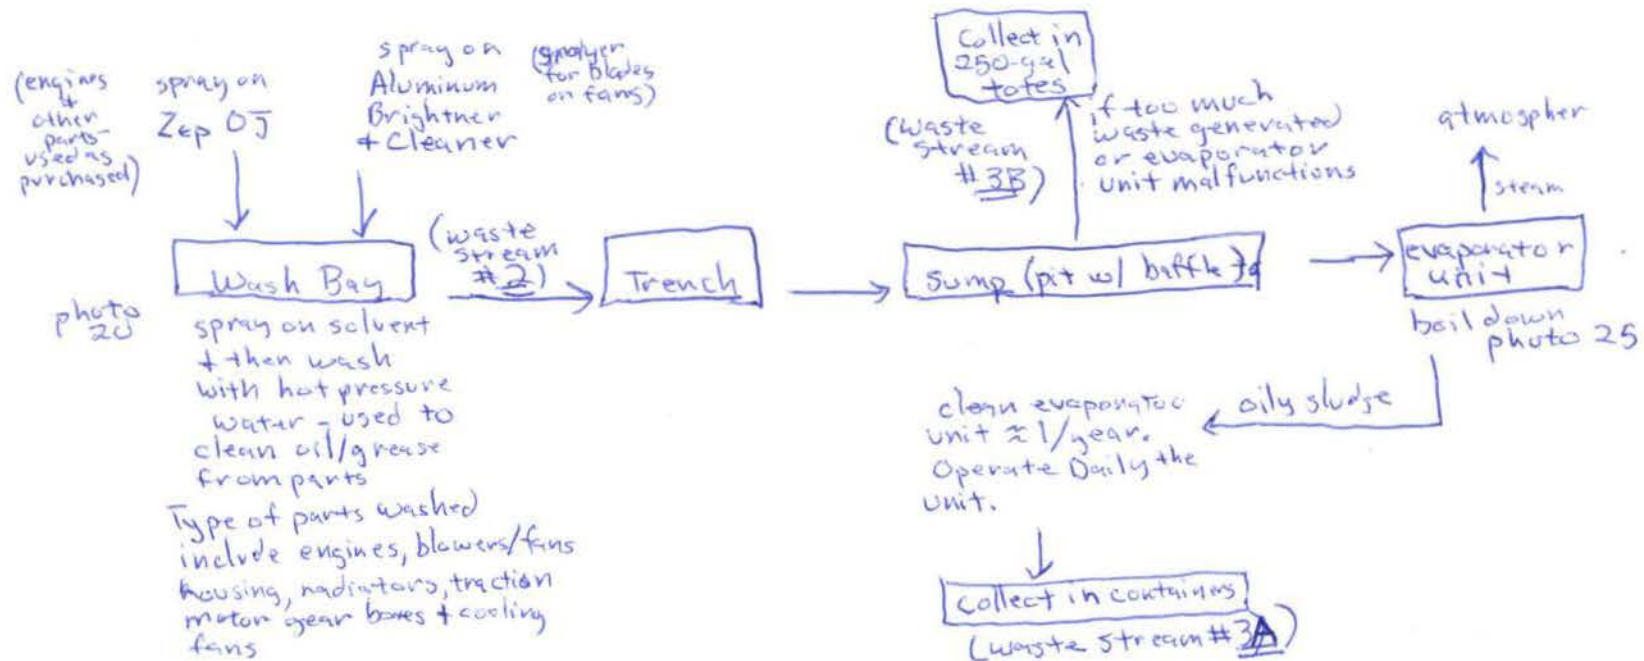
Omega Capital, Gering, NE
Figure 1: Wash Bay Process Diagram

#	WASTE NAME	GENERATION PROCESS	HAZARDOUS WASTE DETERMINATION	ESTIMATED GENERATION RATE	ON-SITE MANAGEMENT	OFF-SITE MANAGEMENT
Hazardous Waste Determination Discussion – At the time of the inspection, the process shown in Figure 1 was determined to be a wastewater treatment system (WWTS) based on discussions with Mr. Gorman. Mr. Gorman stated that even though the WWTS did not have a discharge other than to the atmosphere, NDEQ would view it as a WWTS and OC would be meeting their Clean Water Act (CWA) limits by not having a discharge. Therefore, at the time of the inspection, the wastewater was determined to be RCRA exempt per its discharge to a WWTS. However, it should be noted that the facility representatives did not know why they were evaporating the wastewater instead of oil separating/discharging to the city sewer.						
3	Oily Evaporator Sludge / Oily Evaporator Waste	<p>The WWTS discussed in waste stream #2 generated two waste streams as shown in Figure 1:</p> <p>A. <u>Oily Evaporator Sludge</u> was removed from the evaporator unit (see photo 25). Mr. Williams stated that the evaporator was operated daily and was cleaned about once a year. However, he stated that it had not been cleaned since he was hired. Ms. Ain did not recall when it was last cleaned.</p> <p>B. <u>Oily Evaporator Waste</u> was generated when the evaporator unit malfunctioned or too much wash bay wastewater was generated to be treated as shown on Figure 1.</p>	See the discussion below and Sections 4.4 and 4.5.1 regarding the self-disclosure and hazardous waste determinations needed.	The generation rates of the oily evaporator sludge and waste were unknown, although see the discussion below. Mr. Williams stated that he has not cleaned or removed any waste from the evaporator unit to date. I observed leftover oil related materials on-site as discussed in Section 4.5.1.	The oily evaporation sludge and waste were collected in drums and totes. They were stored in the HW Storage Area. Also, see Sections 4.4 and 4.5.1 regarding the self-disclosure and hazardous waste determinations needed.	Some of the oily evaporator sludge appears to have been shipped off-site to CSI Waste Management, Bennett, CO (unknown for what). Also, see the discussion below and Section 4.4 regarding the self-disclosure.

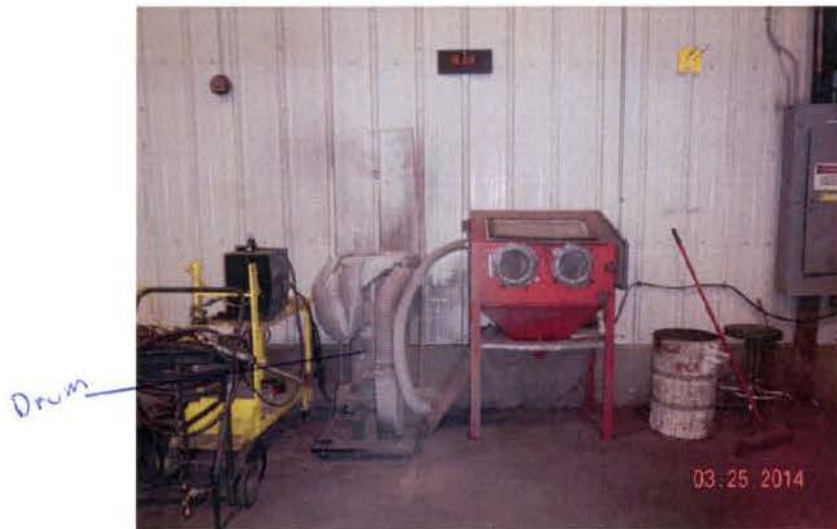
PHOTO 1, 3/25/2014 – Inventory item #2 listed on attachment 4B. The facility location is shown on attachment 4B, page 1. D. Newsome *DN*

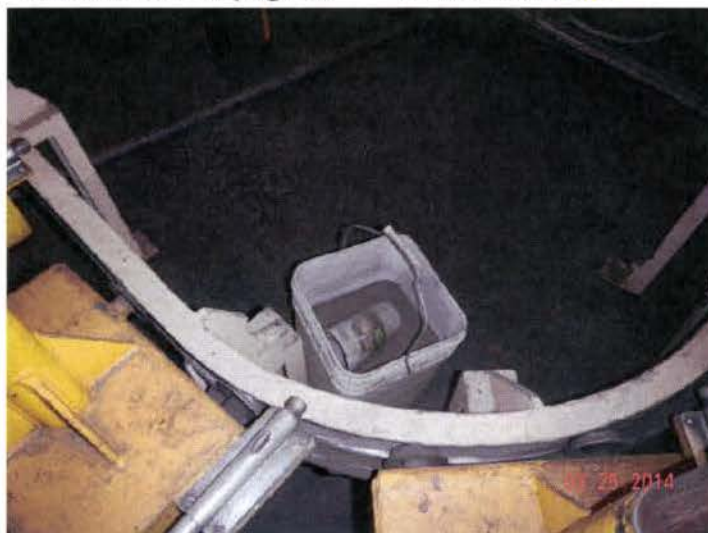
PHOTO 3, 3/25/2014 – Inventory item #3 listed on attachment 4B. The facility location is shown on attachment 4B, page 1. D. Newsome *DN*

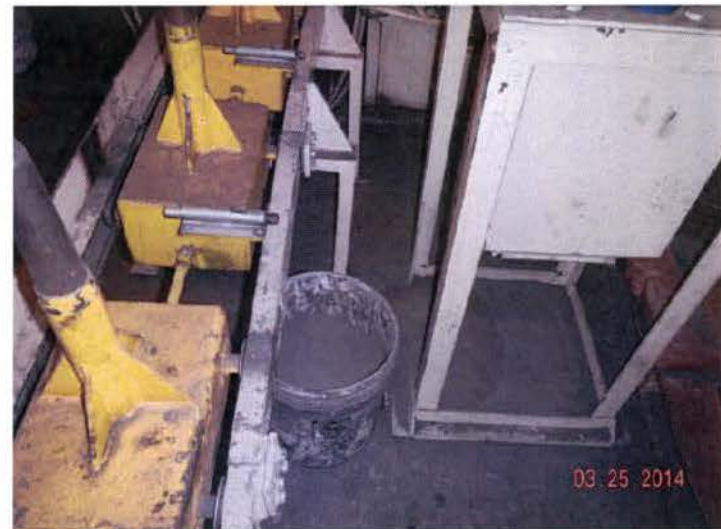
PHOTO 2, 3/25/2014 – Inventory item #3 listed on attachment 4B. The facility location is shown on attachment 4B, page 1. D. Newsome *DN*

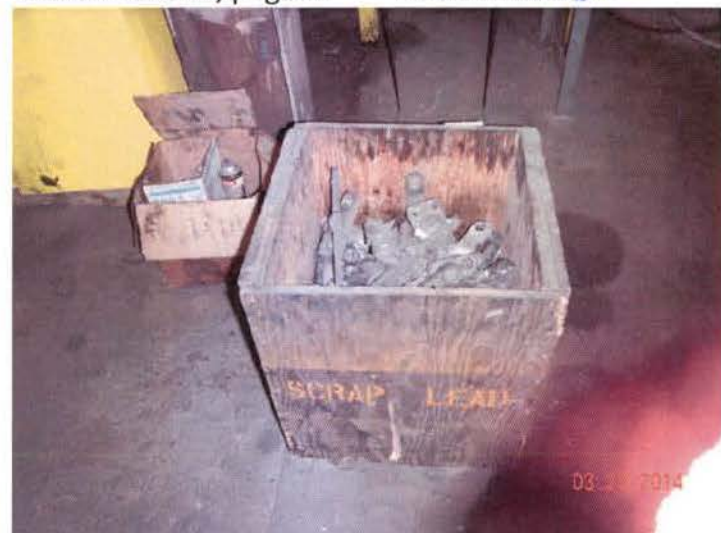
PHOTO 4, 3/25/2014 – Battery Area – Scrap lead bars removed from top of batteries that are to be sent for recycling. D. Newsome *DN*

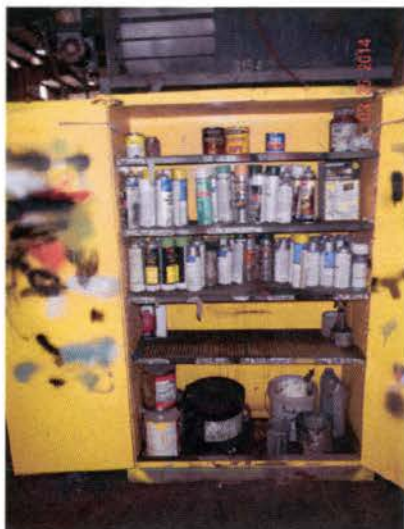
PHOTO 5, 3/25/2014 – Inventory item #4 listed on attachment 4B. The facility location is shown on attachment 4B, page 1. D. Newsome *DN*

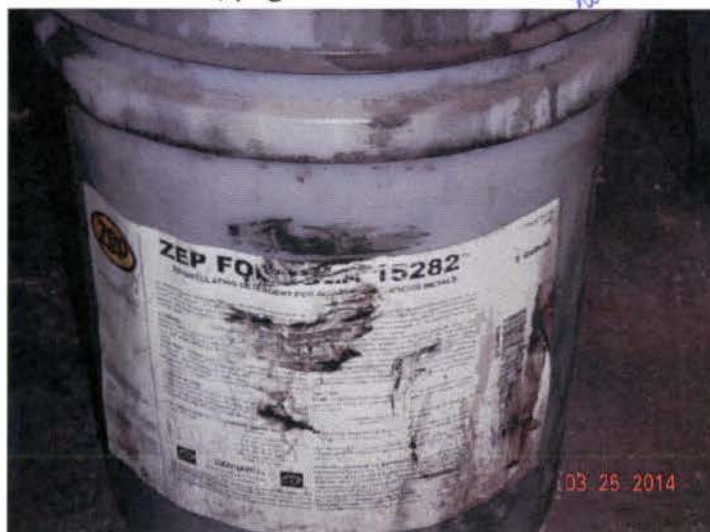
PHOTO 7, 3/25/2014 – Inventory item #5 listed on attachment 4B. The facility location is shown on attachment 4B, page 1. D. Newsome *DN*

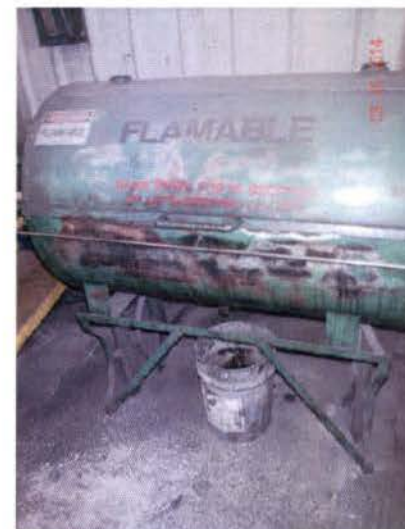
PHOTO 6, 3/25/2014 – Inventory item #5 listed on attachment 4B. The facility location is shown on attachment 4B, page 1. D. Newsome *DN*

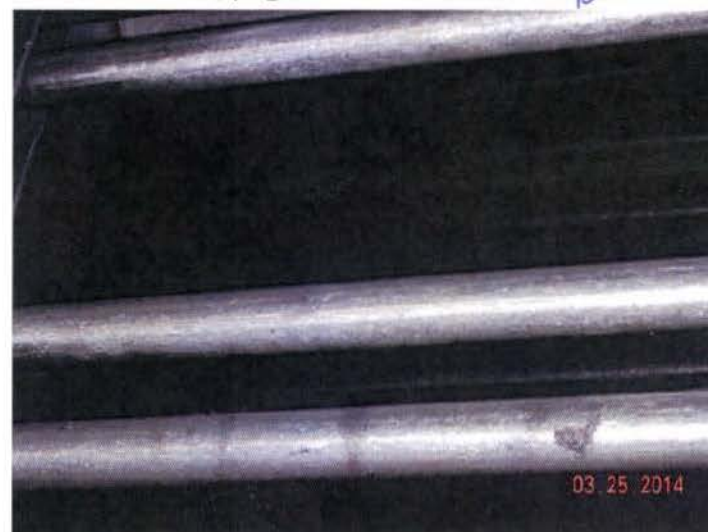
PHOTO 8, 3/25/2014 – Inventory item #5 listed on attachment 4B. The facility location is shown on attachment 4B, page 1. D. Newsome *DN*

looking inside washer

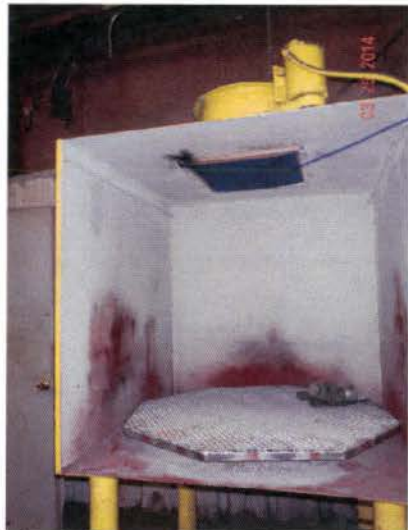
filter

PHOTO 9, 3/25/2014 – Inventory item #6 listed on attachment 4B. The facility location is shown on attachment 4B, page 1. D. Newsome *DN*

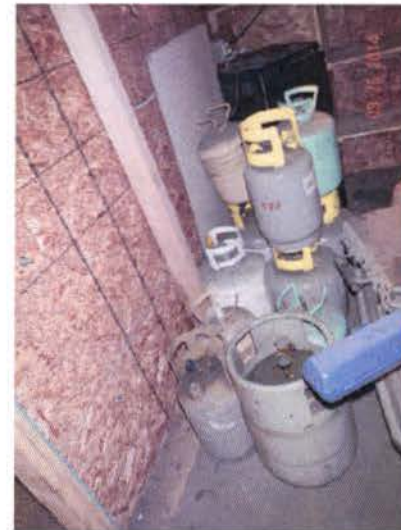
PHOTO 10, 3/25/2014 – Inventory item #7 listed on attachment 4B. The facility location is shown on attachment 4B, page 1. D. Newsome *DN*

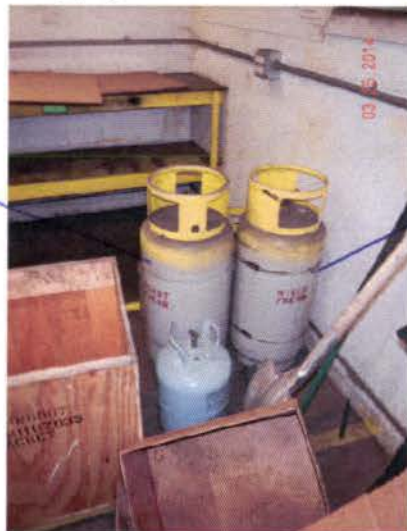
Burnt

Mixed

PHOTO 11, 3/25/2014 – Inventory item #7 listed on attachment 4B. The facility location is shown on attachment 4B, page 1. D. Newsome *DN*

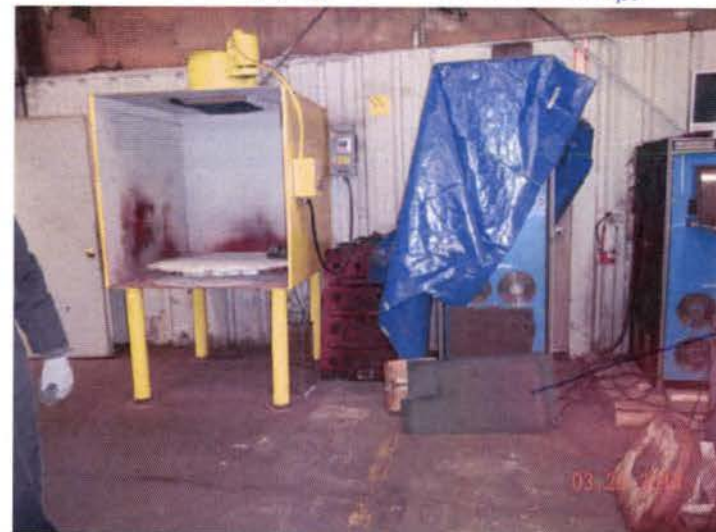
filters
+ foam
sheet

PHOTO 12, 3/25/2014 – Inventory item #6 listed on attachment 4B. The facility location is shown on attachment 4B, page 1. D. Newsome *DN*

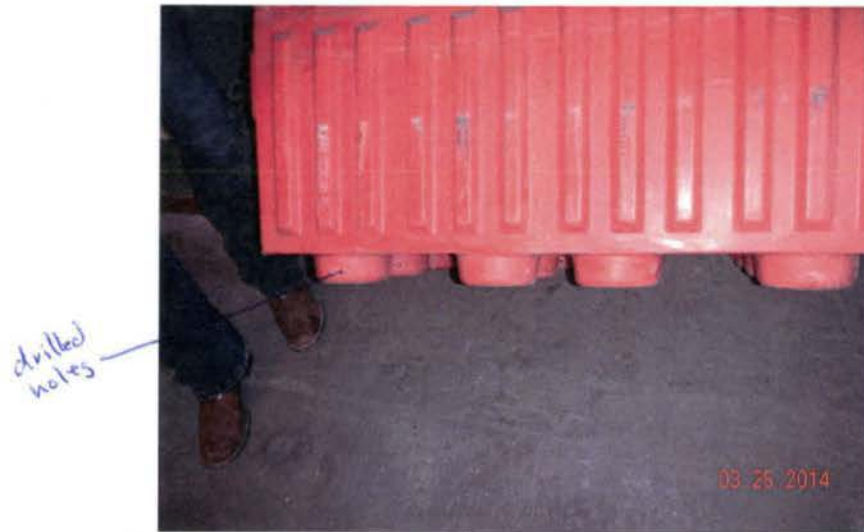
PHOTO 13, 3/25/2014 – Battery Area – Locomotive battery transport container (container was tilted on side for photo) with small holes drilled into each leg. D. Newsome

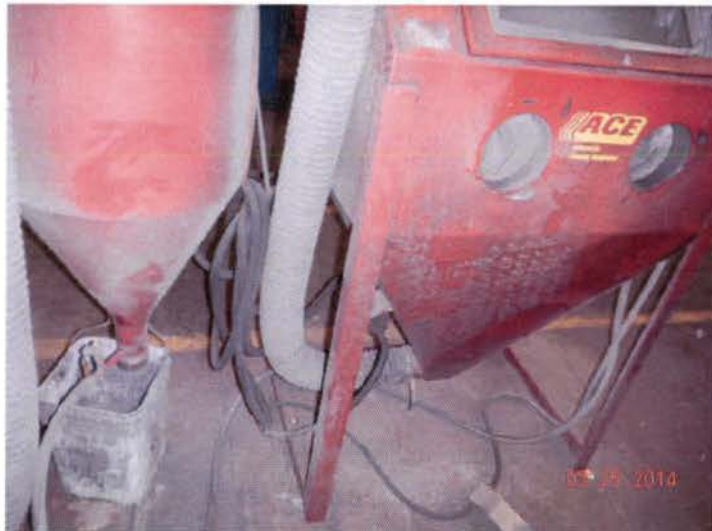
#	LOCATION	QTY	WASTE DESCRIPTION (name, how generated, where came from, why put there, intent, etc.)	HAZ. WASTE DETERMINATION	STORAGE START DATE	PHOTO #
9	Rocker Arm/ Water Pump	unknown qty in unit + 2 1/2 full 5 gal pail	Sand blaster cabinet.	Not made	prior to July 2013	15
10	"	unknown ____ full ____ (calc)	3 parts washer units disconnected blue unit + 1 filter red unit (3' x 18" with 2" soln) Blue/red unit (3' x 18" with 6" soln) Not sure type of solvent used in each	Not Made	prior to July 2013	16
11	"	225 to 300 gal	Water Pump Pressure Testing fluid (light red color) with Rust Inhibitor [in tank]	Not Made	prior to July 2013	17
12	"	25 to 10 gal	White polishing media left in the Almco Vibrator Finishing machine used to clean pins on rocker (maybe returned to customer)	Not Made	prior to July 2013	No photo

PHOTO 15, 3/25/2014 – Inventory item #9 listed on attachment 4B. The facility location is shown on attachment 4B, page 1. D. Newsome

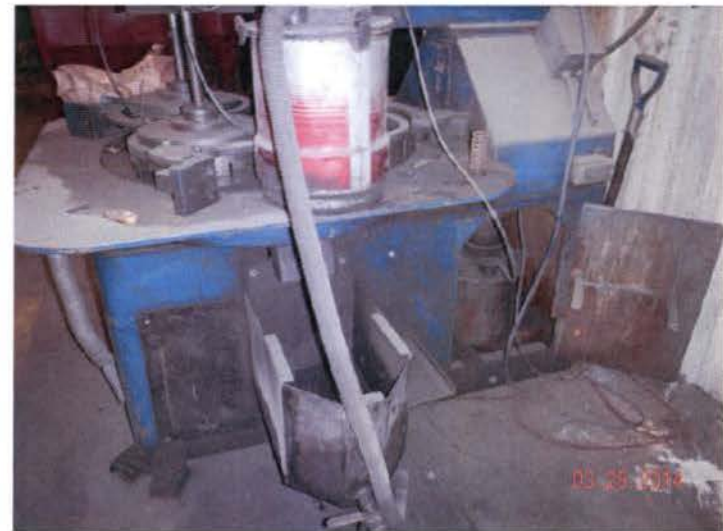
PHOTO 14, 3/25/2014 – Inventory item #8 listed on attachment 4B. The facility location is shown on attachment 4B, page 1. D. Newsome

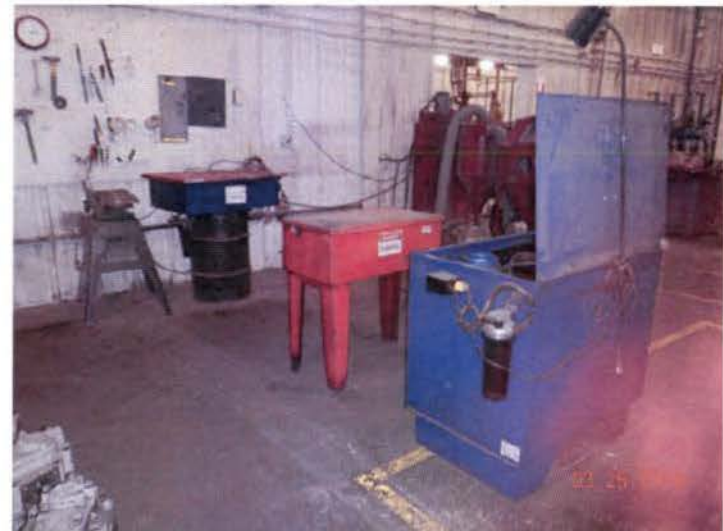
PHOTO 16, 3/25/2014 – Inventory item #10 listed on attachment 4B. The facility location is shown on attachment 4B, page 1. D. Newsome

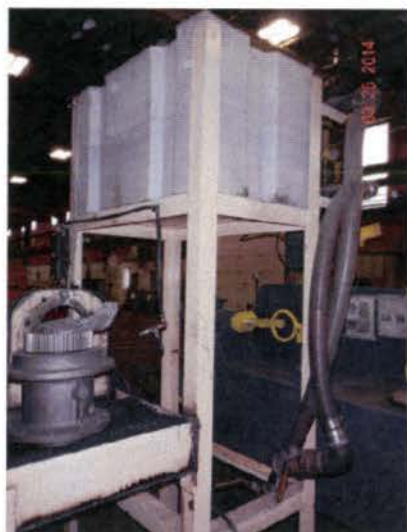
PHOTO 17, 3/25/2014 – Inventory item #11 listed on attachment 4B. The facility location is shown on attachment 4B, page 1. D. Newsome *ND*

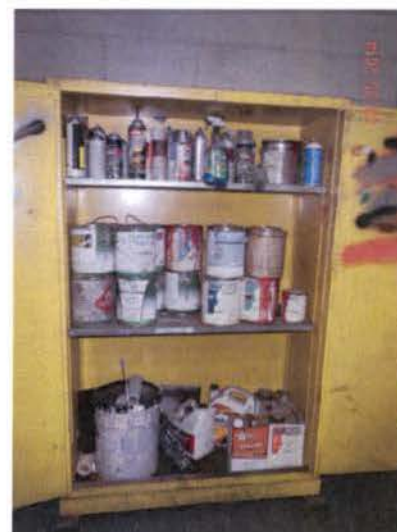
PHOTO 18, 3/25/2014 – Inventory item #13 listed on attachment 4B. The facility location is shown on attachment 4B, page 1. D. Newsome *ND*

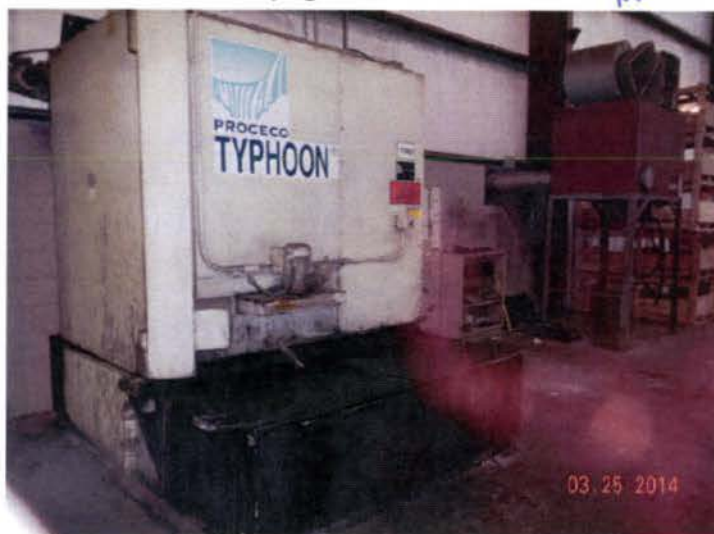
PHOTO 19, 3/25/2014 – Inventory item #14 listed on attachment 4B. The facility location is shown on attachment 4B, page 1. D. Newsome *ND*

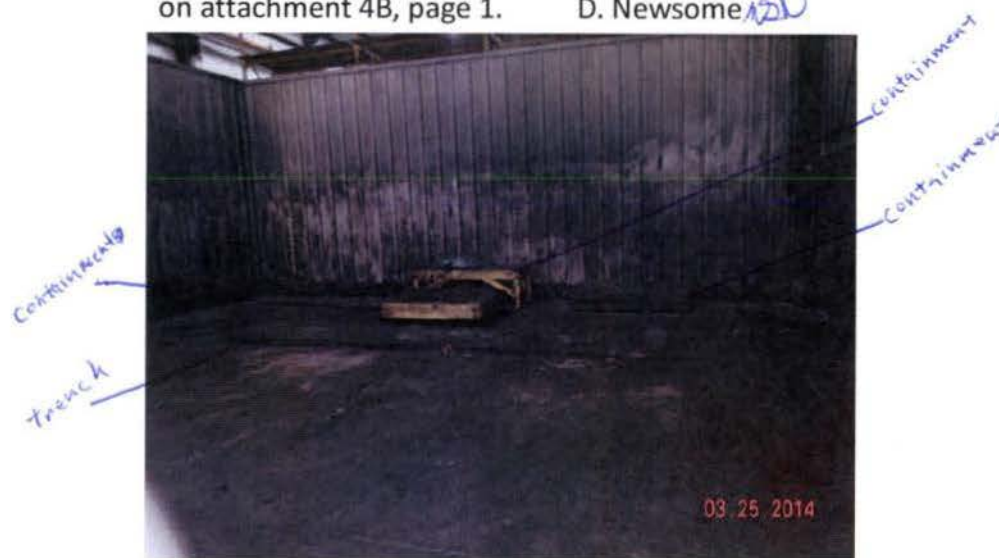
PHOTO 20, 3/25/2014 – Inventory item #15 listed on attachment 4B. The facility location is shown on attachment 4B, page 1. D. Newsome *ND*

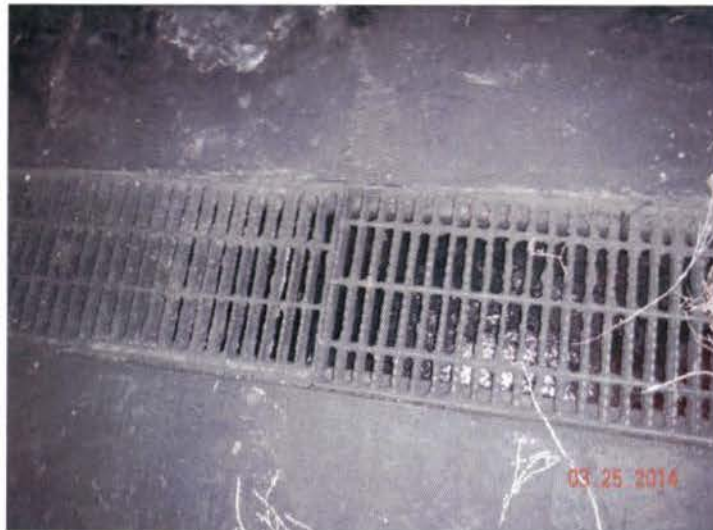
PHOTO 21, 3/25/2014 – Inventory item #15 listed on attachment 4B. The facility location is shown on attachment 4B, page 1. D. Newsome *DN*

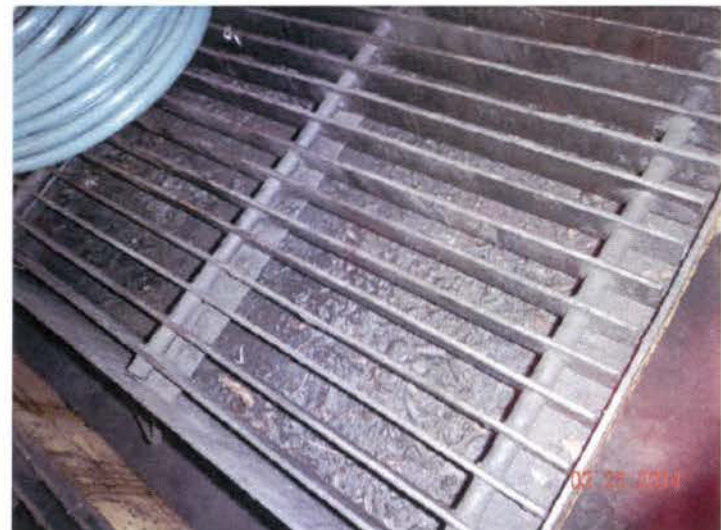
PHOTO 22, 3/25/2014 – Inventory item #15 listed on attachment 4B. The facility location is shown on attachment 4B, page 1. D. Newsome *DN*

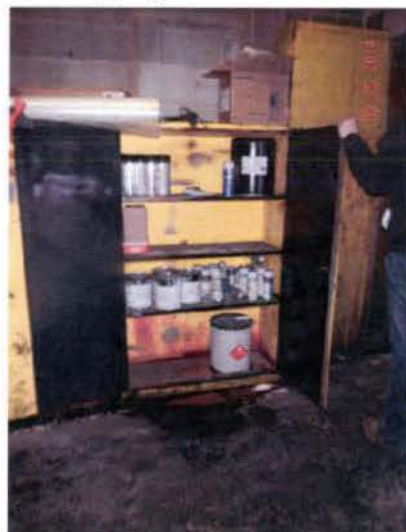
PHOTO 23, 3/25/2014 – Inventory item #20 listed on attachment 4B. The facility location is shown on attachment 4B, page 1. D. Newsome *DN*

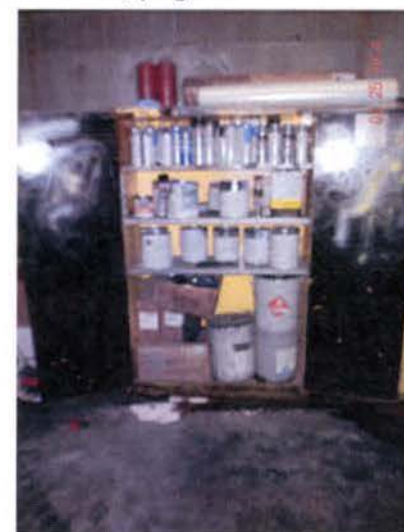
PHOTO 24, 3/25/2014 – Inventory item #19 listed on attachment 4B. The facility location is shown on attachment 4B, page 1. D. Newsome *DN*

evaporator unit

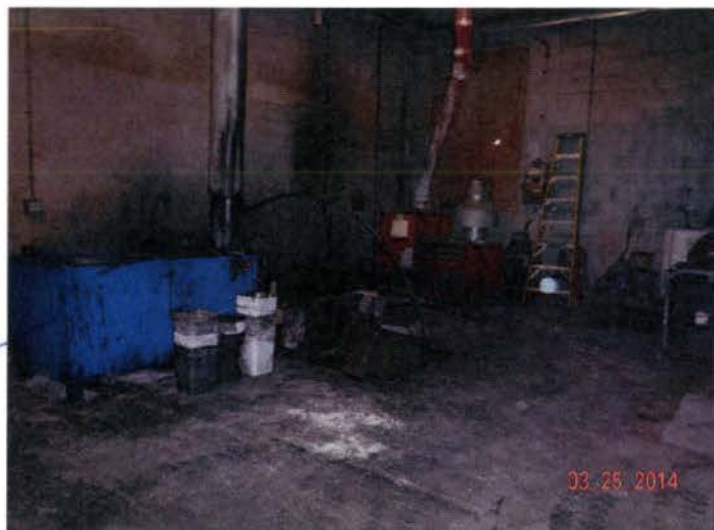
PHOTO 25, 3/25/2014 – Inventory items #16 and #17 listed on attachment 4B. The facility location is shown on attachment 4B, page 1. D. Newsome *DN*

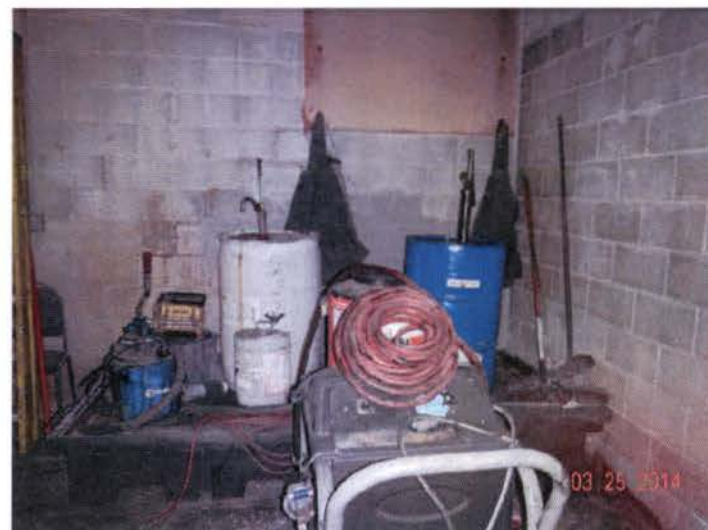
PHOTO 26, 3/25/2014 – Inventory items #15 and #18 listed on attachment 4B. The facility location is shown on attachment 4B, page 1. D. Newsome *DN*

locking inside floor sump next to evaporator

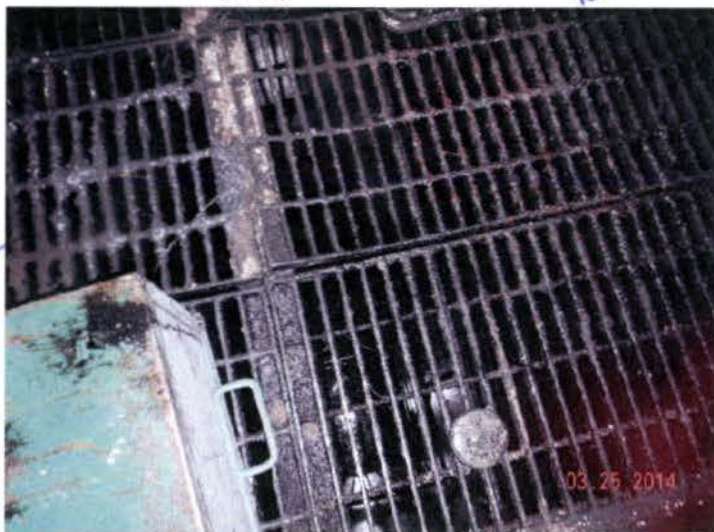
PHOTO 27, 3/25/2014 – Inventory item #16 listed on attachment 4B. The facility location is shown on attachment 4B, page 1. D. Newsome *DN*

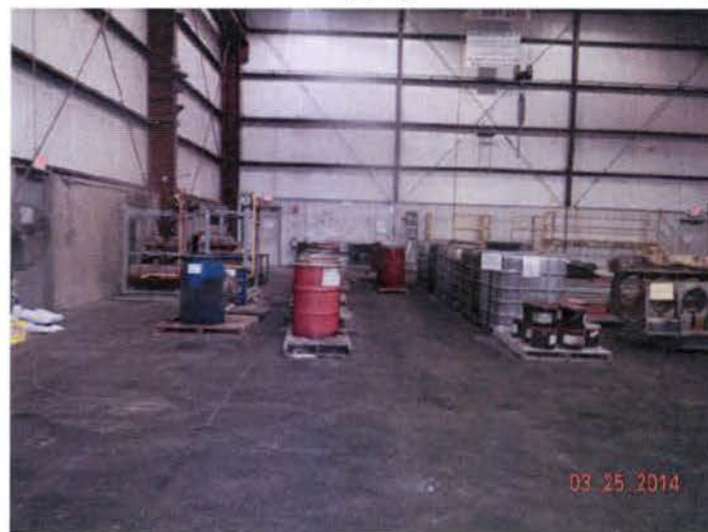
PHOTO 28, 3/25/2014 – HW Storage Area – Inventory listed on attachment 4A (left to right, rows 1 thru 4). The universal waste lamps are stored behind racks against wall on left. The facility location is shown on attachment 7B. D. Newsome *DN*

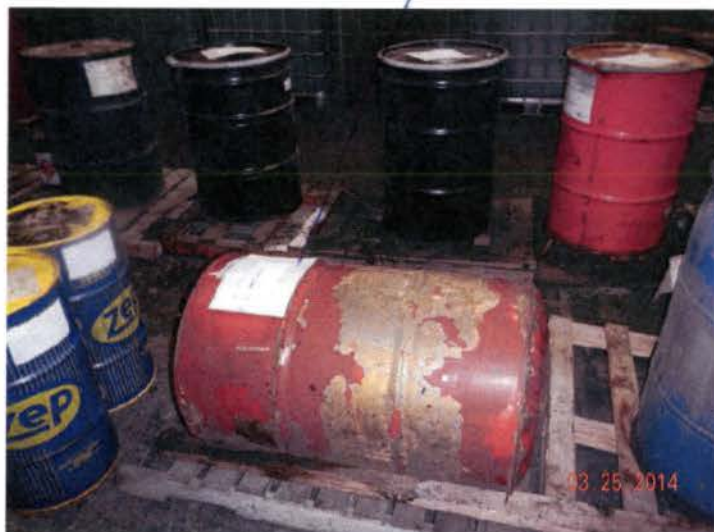
PHOTO 29, 3/25/2014 – Inventory item #2 listed on attachment 4A. See photo 28 and attachment 7B for location. D. Newsome *DNW*

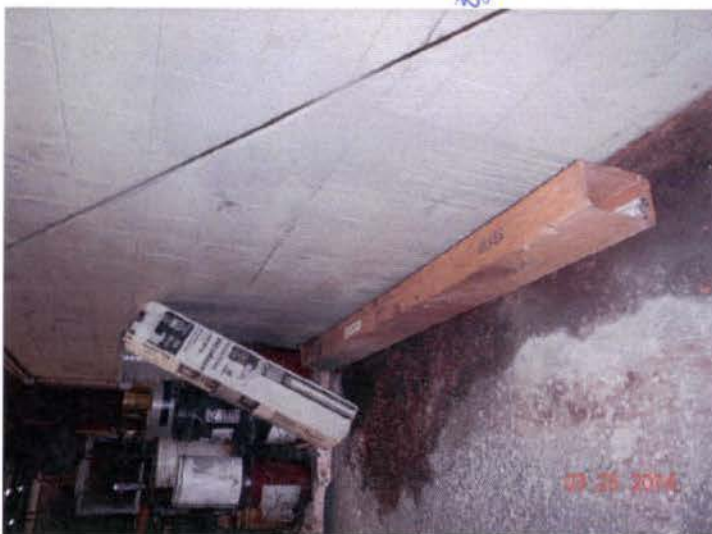
Open Universal Waste Lamps (Not Listed on the NOV) – According to Title 128, Chapter 25, 012.04A, containers of universal waste lamps must be closed. At the time of the inspection, I observed the box of spent 8ft fluorescent lamps open (see photo 31). I discussed this with Mr. Williams and Mr. Perkins and they stated that it would be closed.

PHOTO 31, 3/25/2014 – Inventory item #33 listed on attachment 4A. See photo 28 and attachment 7B for location. Also, open 8ft box of universal waste lamps laying on floor and 4ft box leaning against the wall. D. Newsome *DNW*

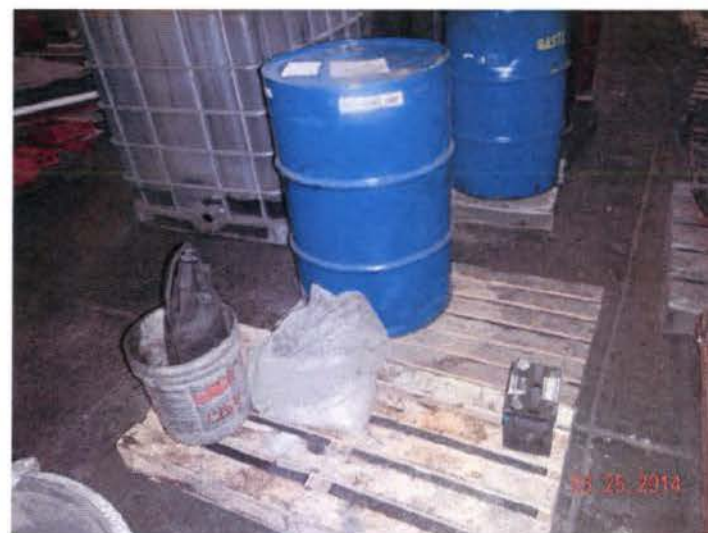
PHOTO 30, 3/25/2014 – Inventory items #21 thru #24 listed on attachment 4A. See photo 28 and attachment 7B for location. D. Newsome *DNW*

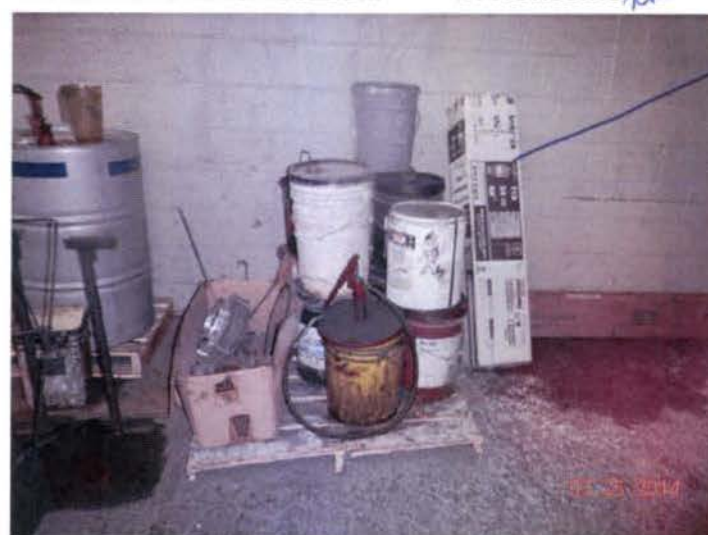
PHOTO 32, 3/25/2014 – Inventory item #33 listed on attachment 4A. See photo 28 and attachment 7B for location. Also, open 8ft box of universal waste lamps laying on floor and 4ft box leaning against the wall. D. Newsome *DNW*

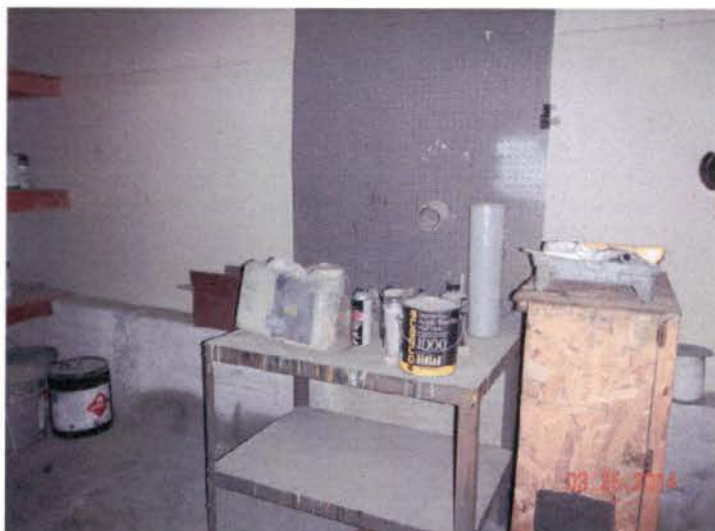
PHOTO 33, 3/25/2014 – Inventory item #21 listed on attachment 4B. The facility location is shown on attachment 4B, page 1. D. Newsome *DNW*

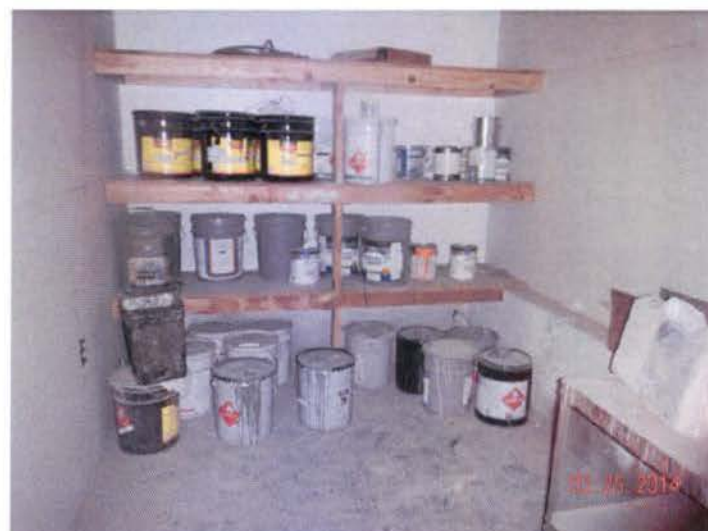
PHOTO 34, 3/25/2014 – Inventory item #21 listed on attachment 4B. The facility location is shown on attachment 4B, page 1. D. Newsome *DNW*

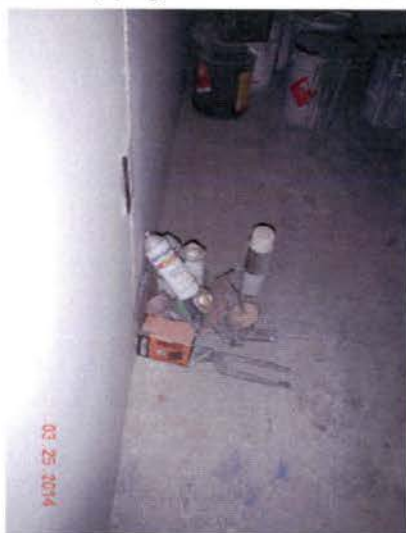
PHOTO 35, 3/25/2014 – Inventory item #21 listed on attachment 4B. The facility location is shown on attachment 4B, page 1. D. Newsome *DNW*

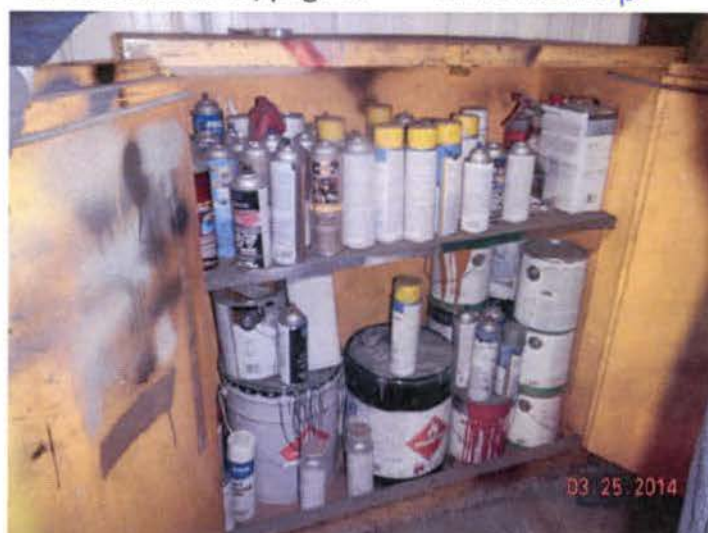
PHOTO 36, 3/25/2014 – Inventory item #22 listed on attachment 4B. The facility location is shown on attachment 4B, page 1. D. Newsome *DNW*

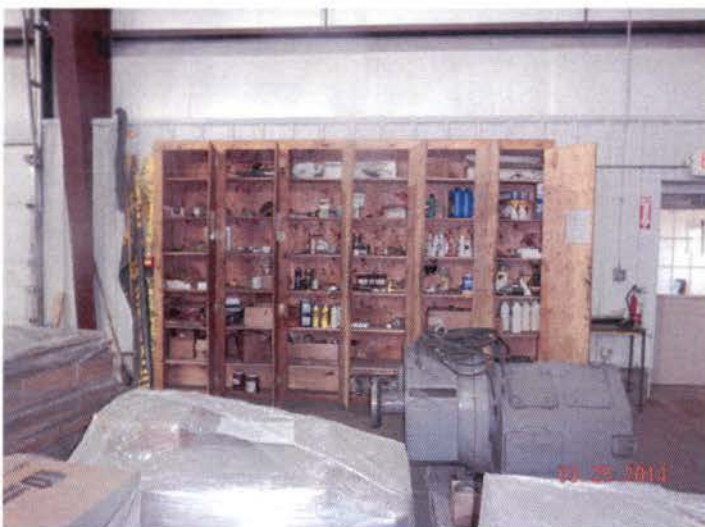
PHOTO 37, 3/25/2014 – Inventory item #1 listed on attachment 4B. The facility location is shown on attachment 4B, page 1. D. Newsome *ND*

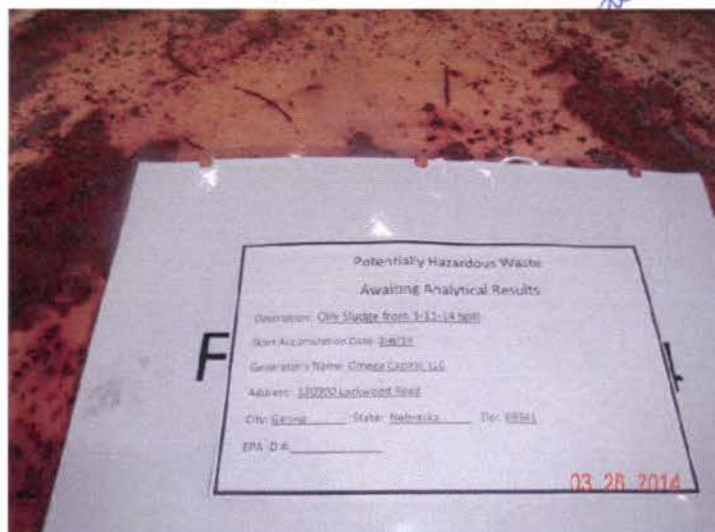
PHOTO 39, 3/26/2014 – Close-up of one of the labels on the drums located in the HW Storage Area shown in photo 28. D. Newsome *ND*

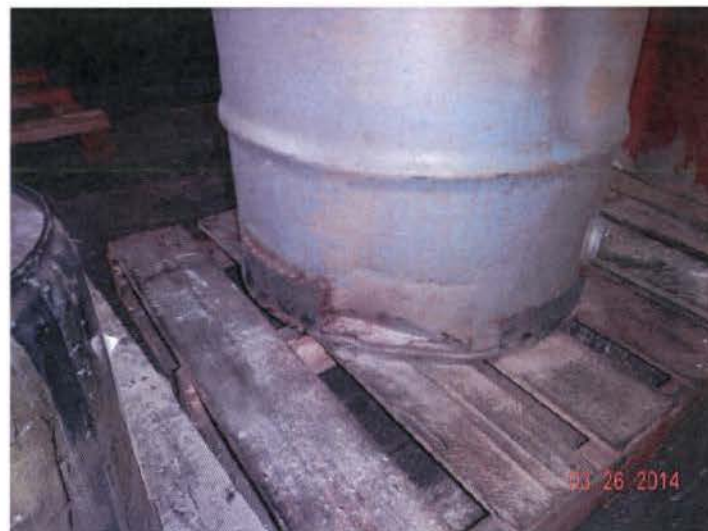
PHOTO 38, 3/26/2014 – Inventory item #10 listed on attachment 4A. See photo 28 and attachment 7B for location. D. Newsome *ND*

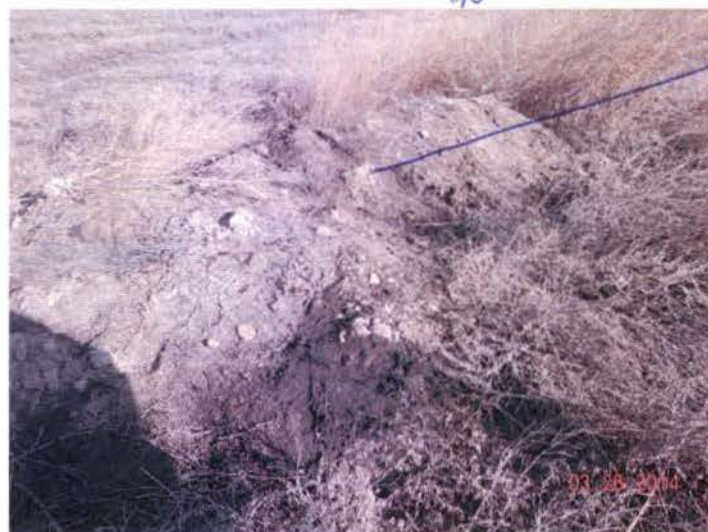
PHOTO 40, 3/26/2014 (facing N) – Inventory item #1 listed on attachment 4C. The facility location is shown on attachment 4C, page 1 and GPS reading included on attachment 10. D. Newsome *ND*

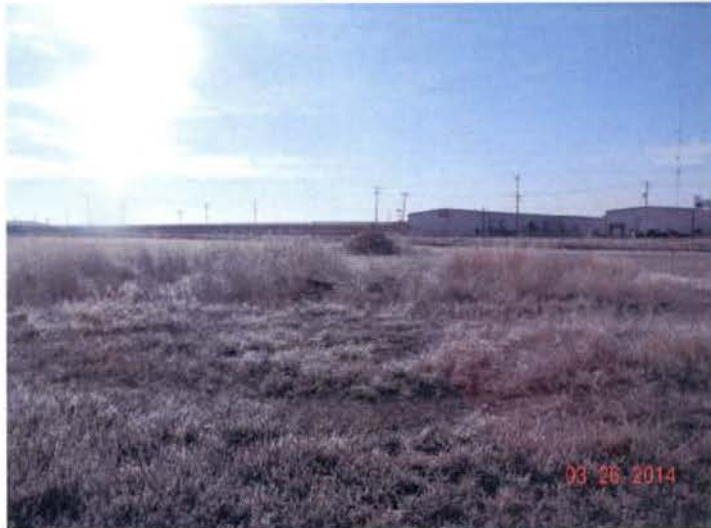
PHOTO 41, 3/26/2014 (facing SE) – Inventory item #1 listed on attachment 4C. The facility location is shown on attachment 4C, page 1 and GPS reading included on attachment 10. D. Newsome *ND*

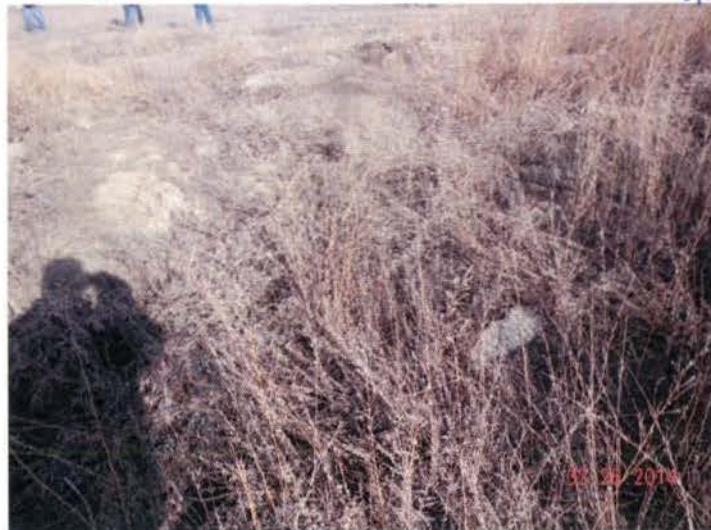
PHOTO 43, 3/26/2014 (facing NW) – Inventory item #1 listed on attachment 4C. The facility location is shown on attachment 4C, page 1 and GPS reading included on attachment 10. D. Newsome *ND*

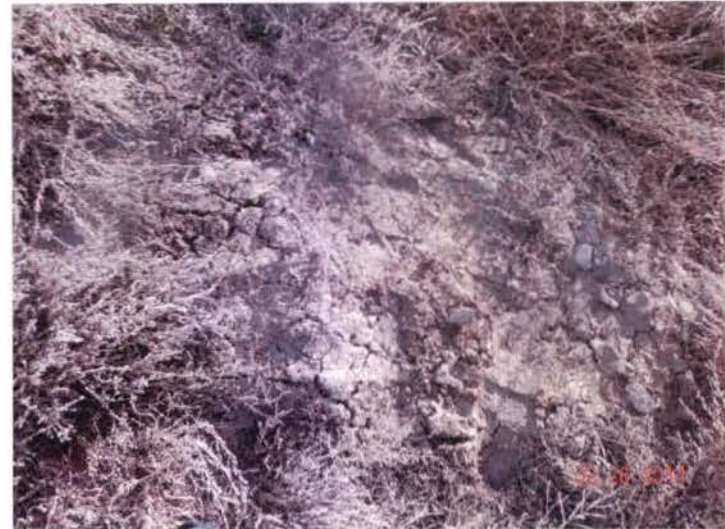
PHOTO 42, 3/26/2014 (facing N) – Inventory item #1 listed on attachment 4C. The facility location is shown on attachment 4C, page 1 and GPS reading included on attachment 10. D. Newsome *ND*

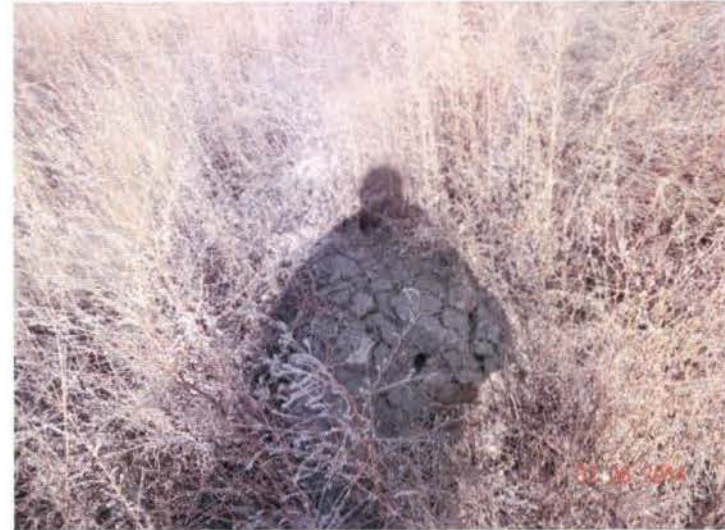
PHOTO 44, 3/26/2014 (facing N) – Inventory item #1 listed on attachment 4C. The facility location is shown on attachment 4C, page 1 and GPS reading included on attachment 10. D. Newsome *ND*

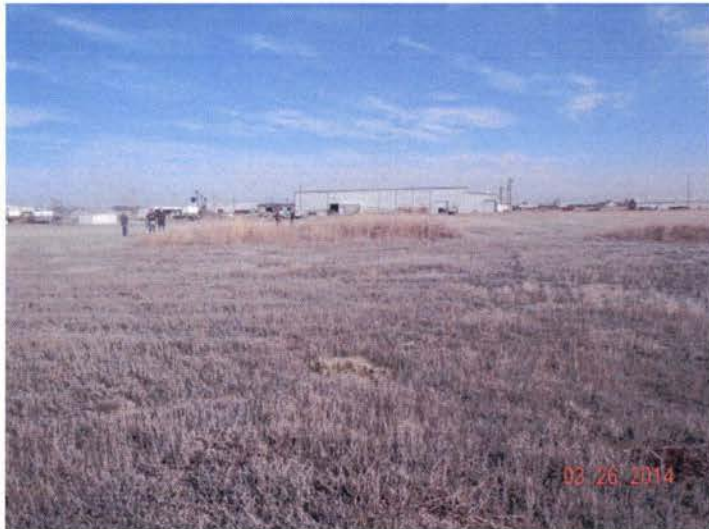
PHOTO 45, 3/26/2014 (facing N) – Inventory item #1 listed on attachment 4C. The facility location is shown on attachment 4C, page 1 and GPS reading included on attachment 10. D. Newsome

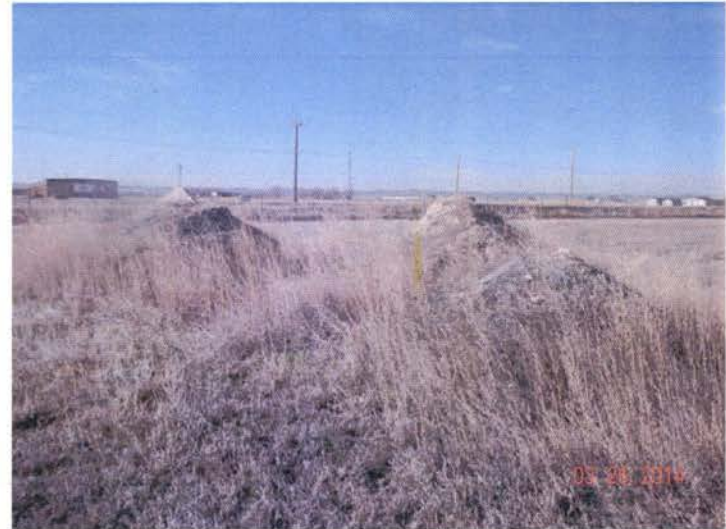
PHOTO 46, 3/26/2014 (facing NE) – Inventory item #2 listed on attachment 4C. The facility location is shown on attachment 4C, page 1 and GPS reading included on attachment 10. D. Newsome

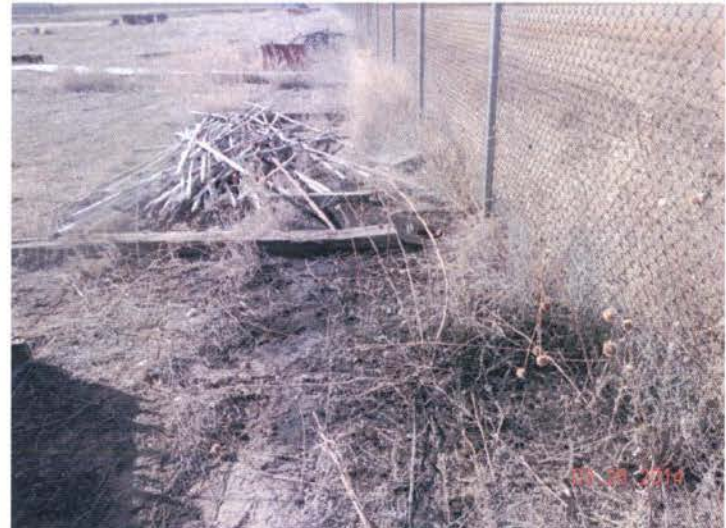
PHOTO 47, 3/26/2014 (facing NE) – Inventory item #2 listed on attachment 4C. The facility location is shown on attachment 4C, page 1 and GPS reading included on attachment 10. D. Newsome

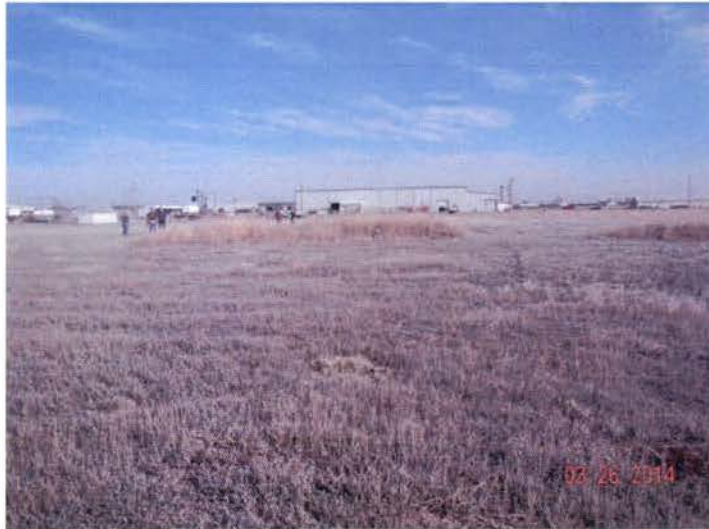
PHOTO 48, 3/26/2014 (facing S) – Inventory item #3 listed on attachment 4C. The facility location is shown on attachment 4C, page 1 and GPS reading included on attachment 10. D. Newsome

See the disclosure documents in attachments 6A and 6B for the details OC stated about this claim. There were three main areas that Mr. Williams pointed out as being identified by former employees concerning this claim (see attachment 4C, page 1 and photos 48 through 49 and 54 through 59). They are noted as Area 3, 4 and 5 on attachment 4C, page 1. The GPS readings are included on attachment 10. I observed some dark stains on and just below the surface in the areas as shown in photos 48 through 50 and 55 through 58.

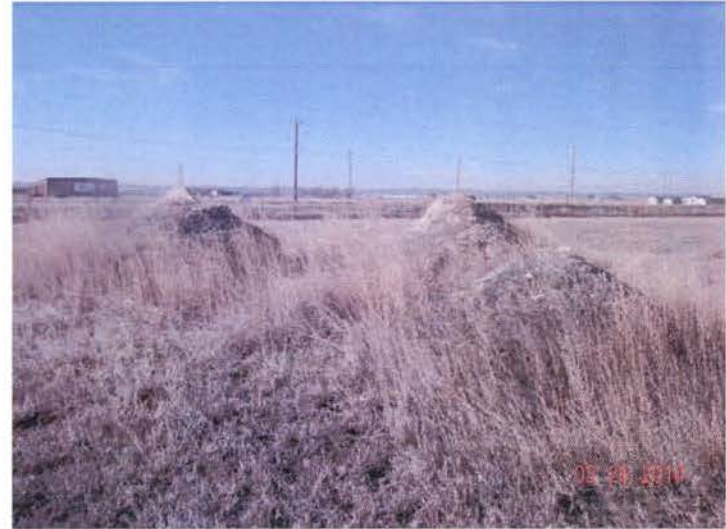
PHOTO 45, 3/26/2014 (facing N) – Inventory item #1 listed on attachment 4C. The facility location is shown on attachment 4C, page 1 and GPS reading included on attachment 10. D. Newsome *DN*

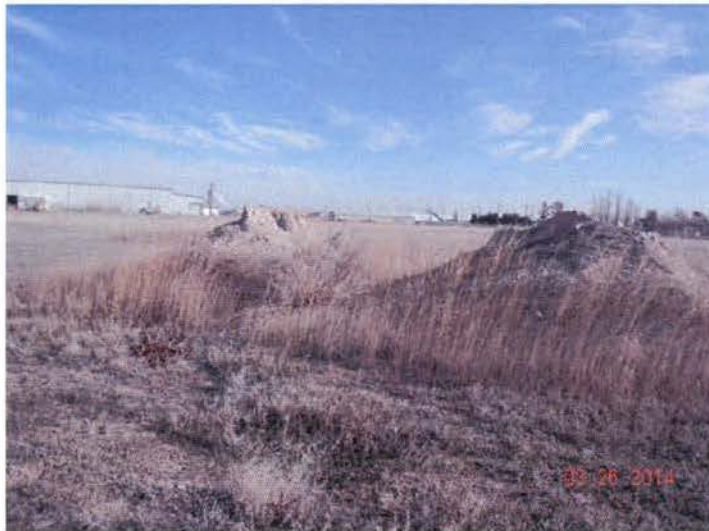
PHOTO 46, 3/26/2014 (facing NE) – Inventory item #2 listed on attachment 4C. The facility location is shown on attachment 4C, page 1 and GPS reading included on attachment 10. D. Newsome *DN*

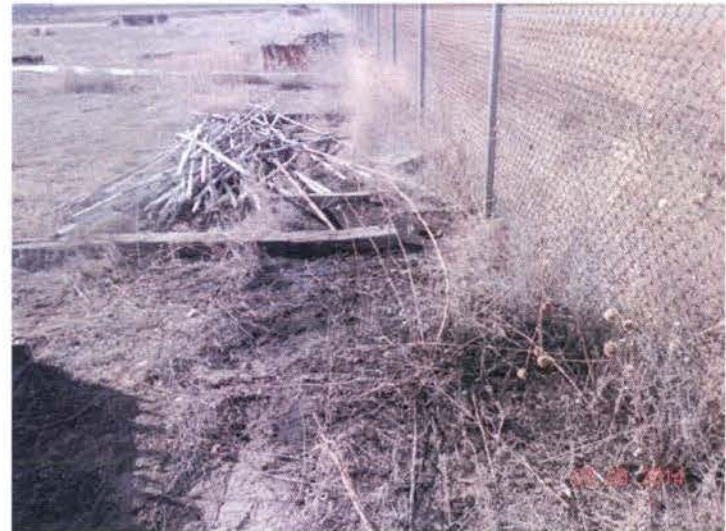
PHOTO 47, 3/26/2014 (facing NE) – Inventory item #2 listed on attachment 4C. The facility location is shown on attachment 4C, page 1 and GPS reading included on attachment 10. D. Newsome *DN*
